Details	Information
Name of the Mine	Hutti Gold Mine
Owner of the Mine	M/s Hutti Gold Mines Company Limited
Date and time of accident	On 06.05.2019 at about 02:00 hrs (3 rd shift of 05.05.19)
Number of Persons killed	Nil
Number of persons seriously injured	01 (One)
Photographs (maximum 02 numbers)

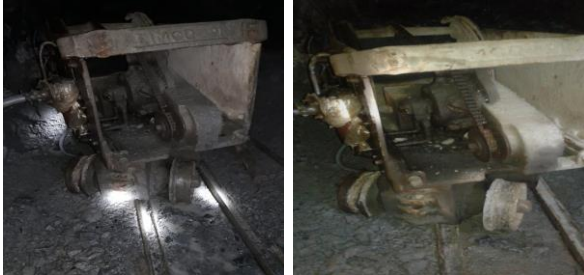
<p data-bbox="756 913 1406 1234"> Picture 01: Picture 02 Picture 02: The rear right wheel lifted and thereafter the complete machine tilted towards the left hand side. The operator who was standing on its left hand side was caught in between the pillar side and the machine. </p>
Prima facie cause of the accident	<p data-bbox="756 1267 1406 1937"> While a pneumatically operated track mounted Rocker Shovel Loader, pushing the bucket for loading blasted waste rock in a drive of an underground gold mine, the lip of the bucket hit the supporting channel of the track line, the right hand side of the loader got lifted up due to the reactive force and the machine tilted towards left hand side, thereby the operator who was standing on its left hand side, caught in between the pillar side and the machine itself, inflicting serious bodily injuries </p>
