# ALERT

Name of the mine : Bharatpur Opencast Mine  
Owner of the Mine : M/s Mahanadi Coalfields Ltd.  
Date and time of the accident : 23.07.2019, 22:30 Hrs  
Number of persons Killed : 4(Four)

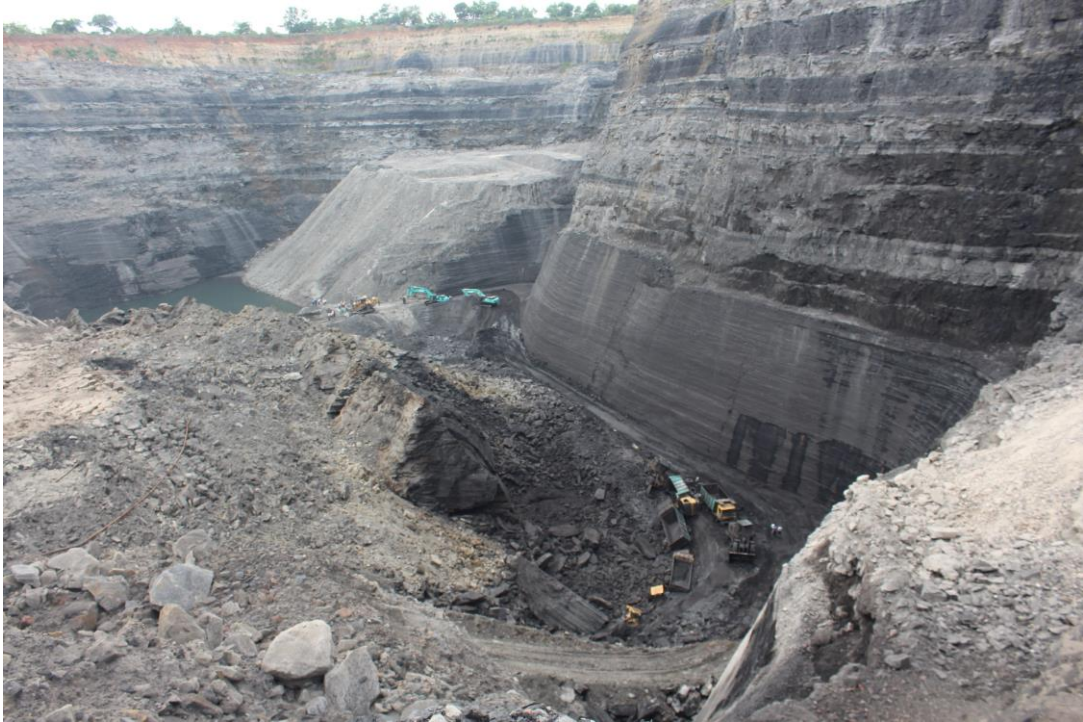
While men & machinery were deployed for extraction of coal in an area dip-side of a left out rib of coal and overburden having width of about 03 m at top and of height of about 39 m against which backfilling was done upto a height of about 100m, suddenly the rib failed, causing flow of debris including broken rib, dumped material and slush spreading over an area measuring about 210m (length) X 270m (width), burying men and machinery and inflicting fatal injuries to four persons and nine persons escaped with minor injuries.

block of coal(rib) is left un-extracted have failed and collapsed causing flow of debris causing fatal accidents thus management shall not leave insitu block of coal(rib) un-extracted.

4. The dumped material shall be allowed to settle at not exceeding the natural angle of repose of the material as prescribed in Reg. 108(2) of CMR, 2017. The spoil bank face shall not be retained by artificial means at an angle in excess of its natural angle of repose.

11. The water shall not be allowed to accumulate over the dumps. Proper leveling of the dumped material should be done.
12. The back filled area shall be kept benched and the distance of any active mine workings (faces) from the toe of the bottom-most back filled face (bench) shall not be less than 100 m or height of the OB dump whichever is higher without prior permission from this directorate based on scientific study.
