No. Safety Alert/15

SAFETY ALERT:

SUBJECT: Fatal accident occurred due to (cause) "While replacing rear left hand tyre of 100 ton Dumper at workshop of an opencast mine, instantaneous release of compressed air from the tyre assembly and throwing away of the Rim and flanges of the tyre assembly, hit one the workers in its trajectory resulted in killing one of them on the spot, the other three escaped with minor injuries".

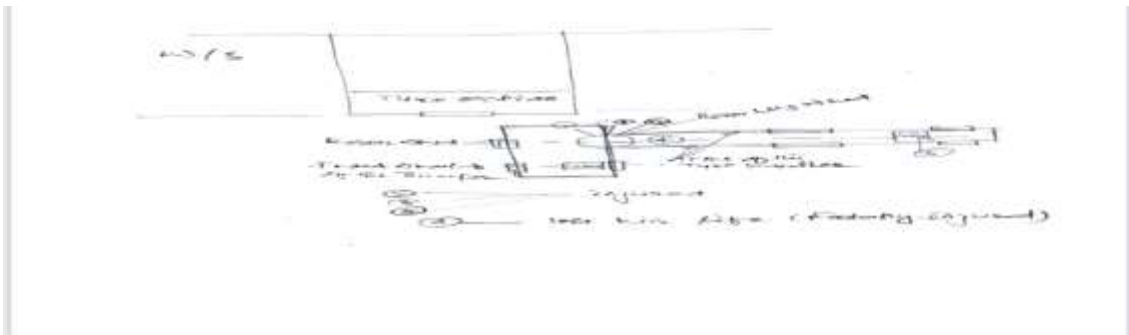
1. Name of Mine : Gua Ore Mines.
2. Name of Owner : M/s SAIL.
District : West Singhbhum.
State : Jharkhand
3. Mineral : Iron Ore
4. Date and time of accident : 22.06.2025 and 04:10 PM
5. Place of accident : workshop of an opencast mine
6. Killed : Name: Late Charan Purty
Designation: fitter helper
Age: 56
Experience: 30 years in fitter helper (work) Operation.
7. Seriously Injured : Nil
8. Brief Cause : While replacing rear left hand tyre of 100 ton Dumper at workshop of an opencast mine, instantaneous release of compressed air from the tyre assembly and throwing away of the Rim and flanges of the tyre assembly, hit one the workers in its trajectory resulted in killing one of them on the spot, the other three escaped with minor injuries.
9. Sketch showing the accident:

10. Best Practices
 1. Always use tyre safety cages during inflation/deflation and Conduct NDT (Non-Destructive Testing) on rims for cracks or fatigue.
 2. Follow standard tyre maintenance SOPs strictly, Deflate tyres completely before dismantling and Keep a safe exclusion zone during tyre work.
 3. Conduct refresher training for all maintenance staff, Introduce visual aids and danger markings around high-risk areas and Train workers in emergency response procedures.
 4. Regularly audit tyre maintenance procedures and Ensure supervisor is always present during high-risk operations.
