भारत सरकार
श्रम एवं रोजगार मंत्रालय
खान सुरक्षा महानिदेशालय

SAFETY ALERT: 06 /2025

SUBJECT: Fatal accident occurred due to the piercing of a roof bolt [used to hang a trailing cable] in the neck of an LHD operator at a junction of an underground coal mine.

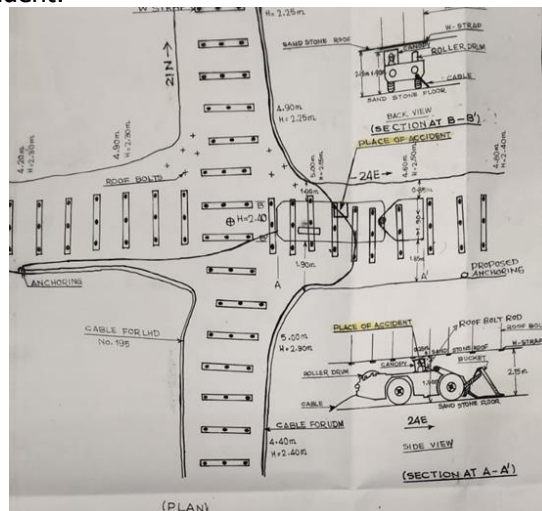
1. Name of Mine : NCPH Colliery R-6 Mine
2. Name of Owner : M/s South Eastern Coalfields Limited
District : Manendragarh-Chirimiri-Bharatpur (MCB)
State : Chhattisgarh
3. Mineral : Coal
4. Date and time of accident : 20.02.2025, 13:45 Hrs
5. Place of accident : 24 LE/21N Development District in Seam-V, At a distance of about 60m from the face
6. Killed : Name: Ramchandra
Designation: Operator
Age: 56 YEARS
Experience: 07 years in LHD Operation.
7. Seriously Injured : Nil
8. Brief Cause : While operating a Load-Haul-Dump (LHD) vehicle underground to lift coal from the coal face, the front portion of a roof bolt rod, which was used for hanging the trailing cable at the junction, pierced the operator's neck below the left ear. He sustained injuries from which he later died.
9. Sketch showing the accident:

- (i) Visual Indicators: Use visual indicators (such as warning signs) in areas where trailing cables or other hazards exist to alert operators of potential risks.
- (ii) Clearance Protocols: Establish strict clearance protocols to ensure that height restrictions are considered before deploying LHDs or other equipment in low-height areas.
- (iii) Standard Operating Procedure: SOP for Trailing Cable Laying in Underground Coal Mines shall be framed and implemented
