# REPORT of HIGH POWERED COMMITTEE on Accident in the Deep Mining Zone of Rajmahal, OCP, ECL on 29 December 2016

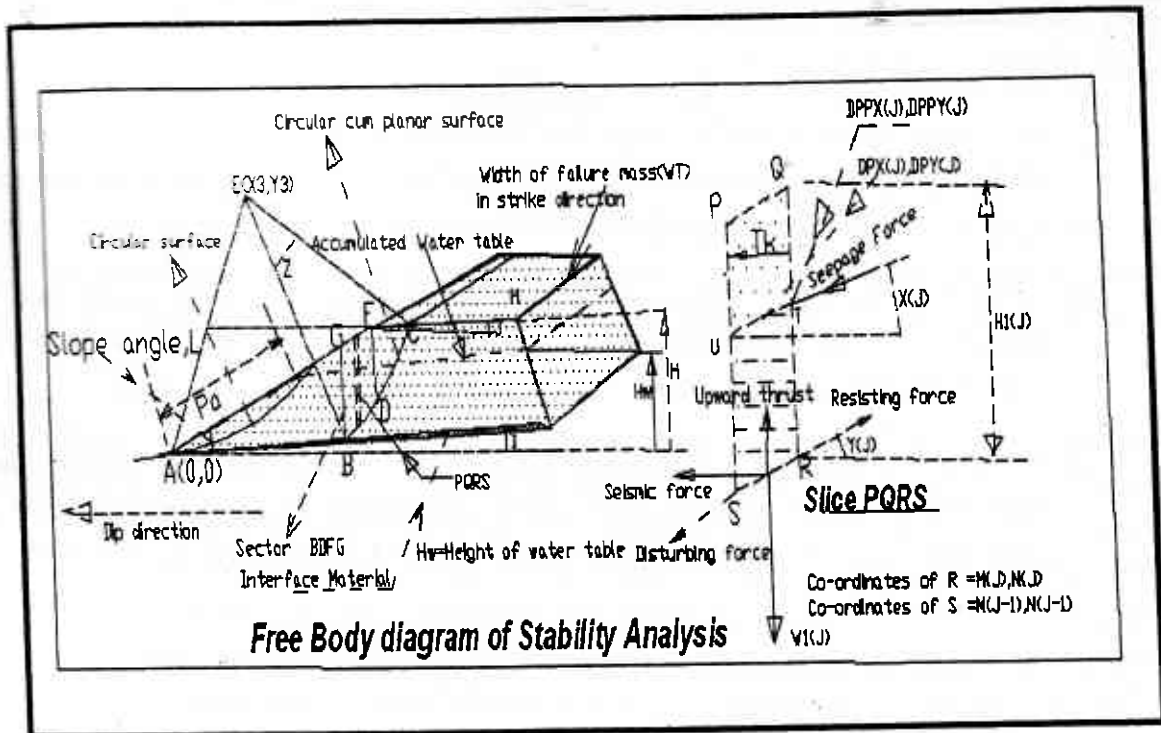
Fig 7: Free Body diagram of Stability Analysis

- a) Angle of internal friction =  $32^\circ$
- b) Cohesion =  $70 \text{ kN/m}^2$
- c) Bulk unit weight =  $20 \text{ kN/m}^3$
