### VOLUME -III

(THIS VOLUME CONTAINS ACCIDENT PLAN, TWO SECTIONS, SEVEN PLATES OF PHOTOGRAPH BEFORE ACCIDENT & NINETEEN PLATES OF PHOTOGRAPH AFTER ACCIDENT.)

**MINE PLAN, SECTIONS**  
**&**  
**PLATES OF PHOTOGRAPHS**

Sl. No.	TITLE	Nos.
1.	Accident plan bearing No. DGMS/SHQ/ACCIDENT/01/2017 dated 27.01.2017	01
2.	Sections drawn (A-A', B-B' & C-C') at an interval of 100m showing the profile of failure bearing No. DGMS/SHQ/B/ACCIDENT/01/B/2017 dated 27.01.2017	01
3.	Sections drawn (D-D', E-E', F-F' & G-G') at an interval of 100m showing the profile of failure bearing No. DGMS/SHQ/A/ACCIDENT/01/A/2017 dated 27.01.2017	01
4.	Photographs indicating conditions of Dahernangi/20M Patch workings before accident	07 PLATES
4.	Photographs indicating recovery operations	19 PLATES

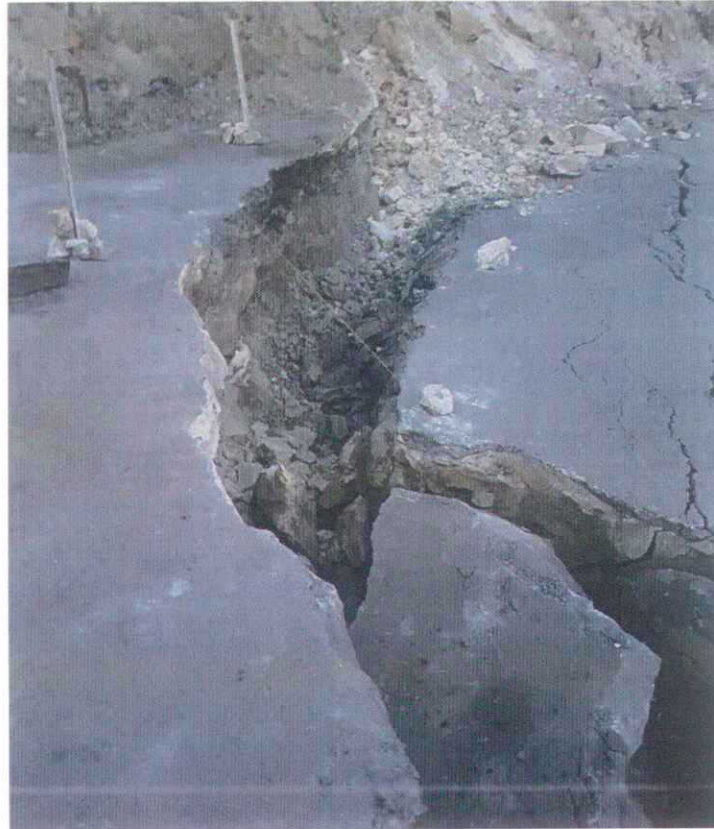
Crack monitoring station

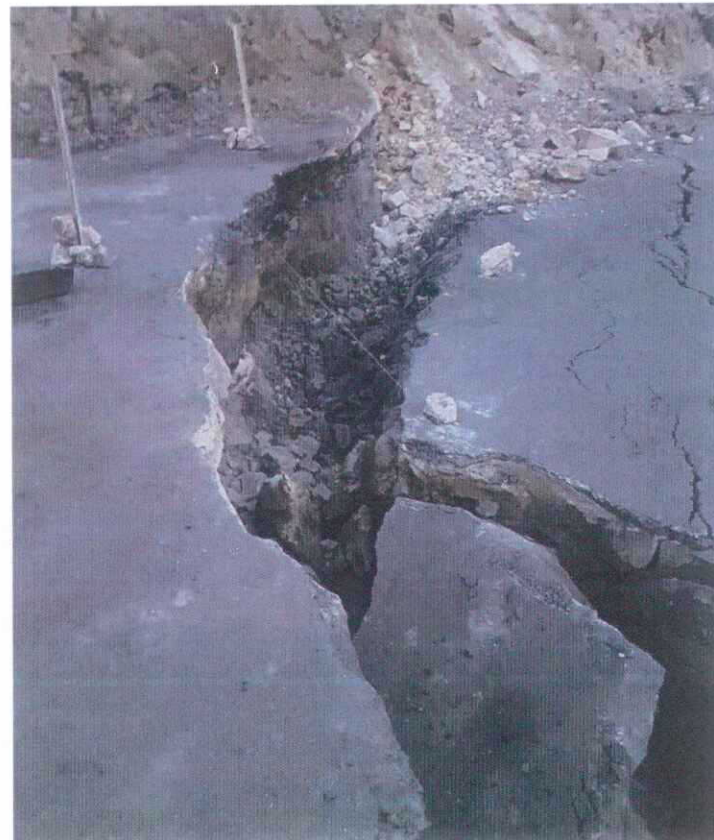
Crack monitoring station

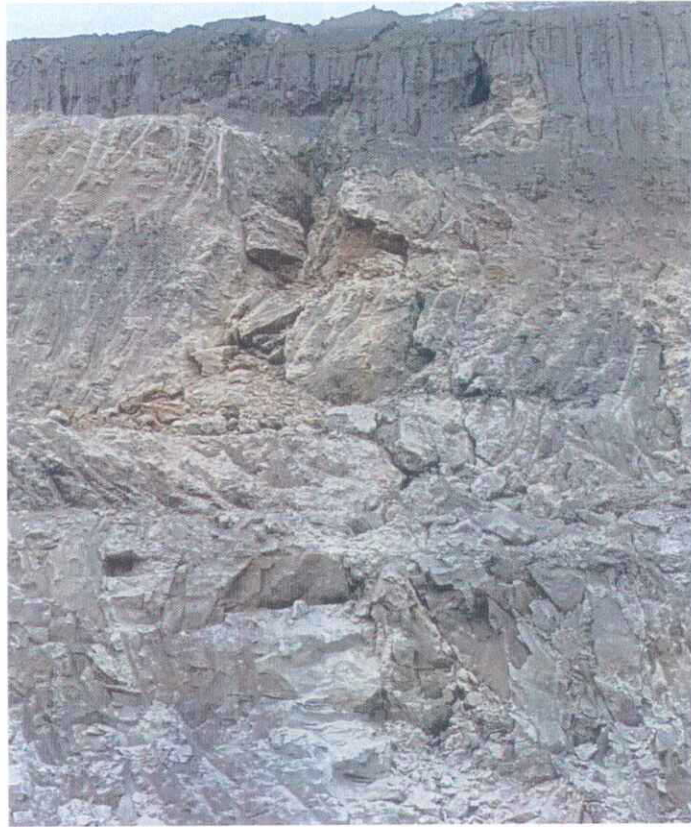
Vertical Crack in in-situ OB bench

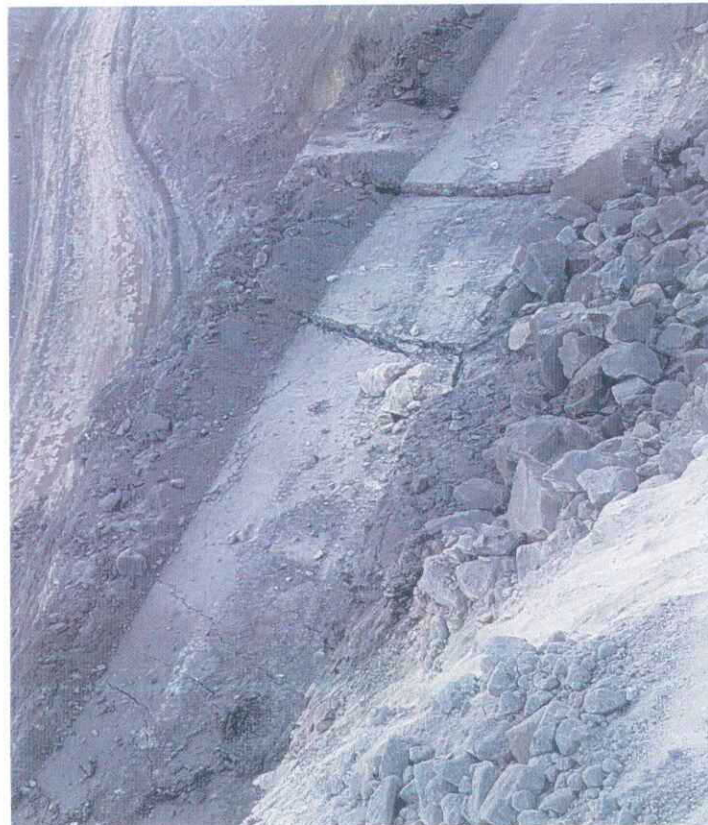
Crack on OB dump haul road.

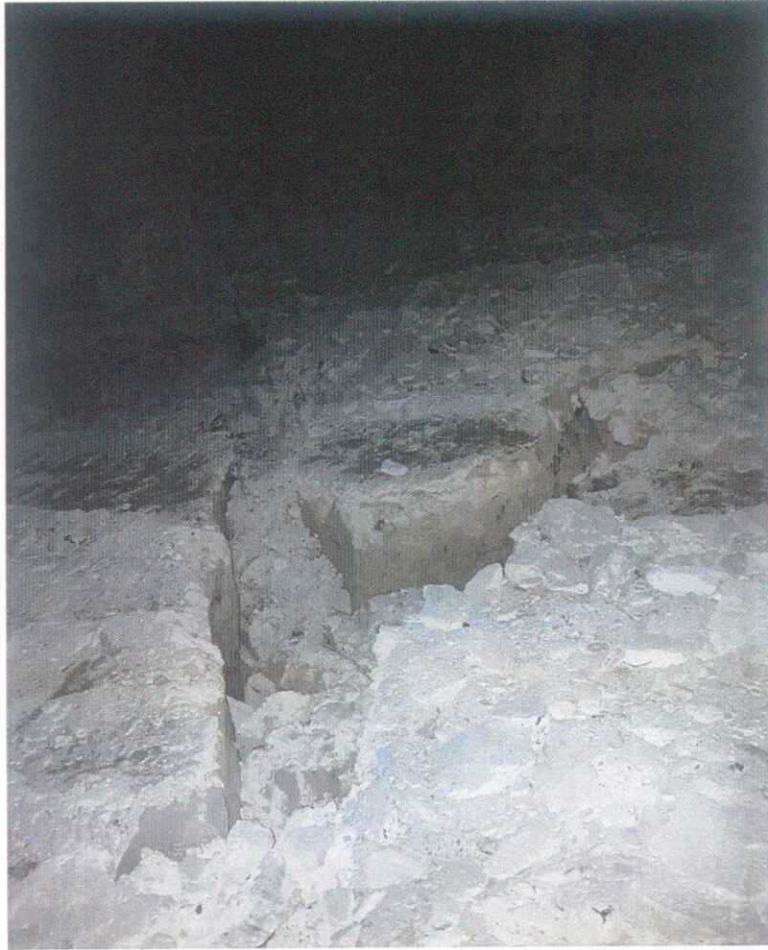
Crack on in-situ OB bench.

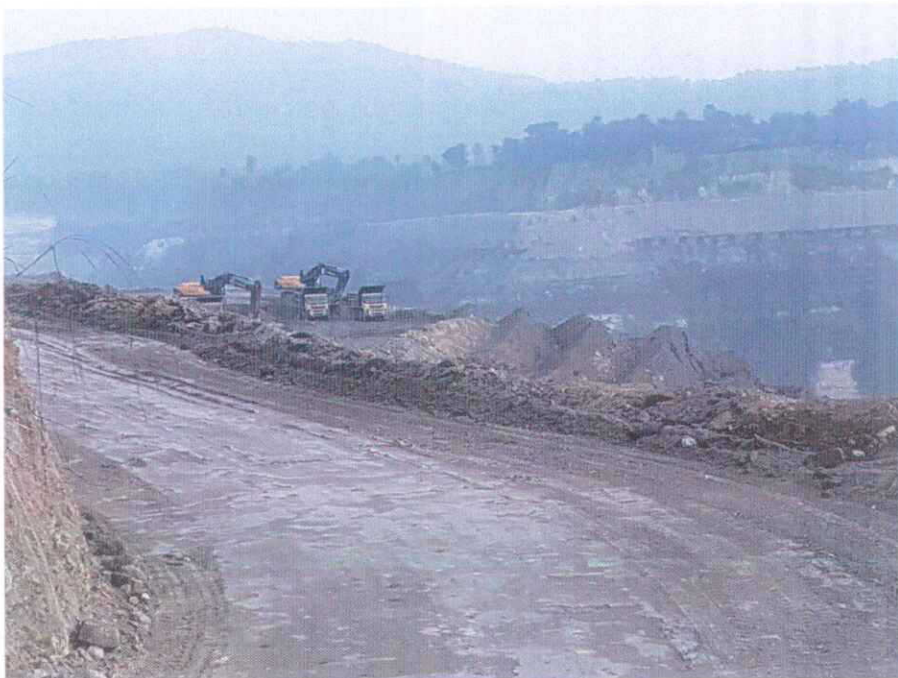
Crack along edges OB dump.

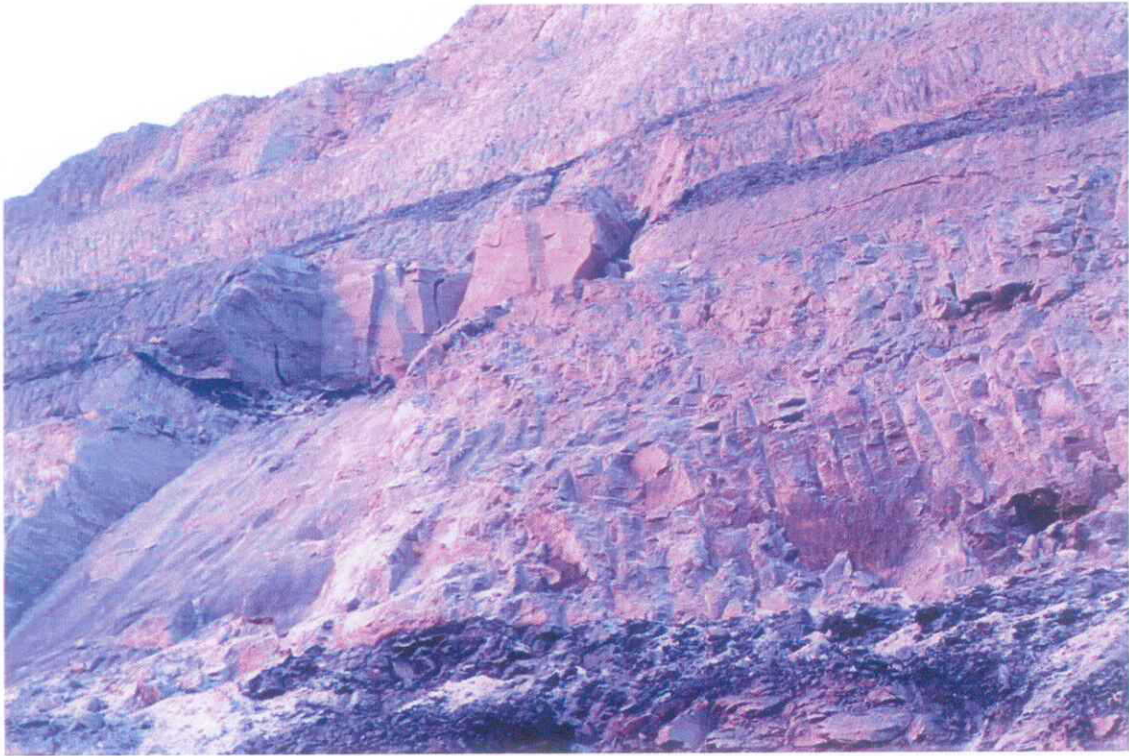
Photograph showing slide of loose in OB bench.

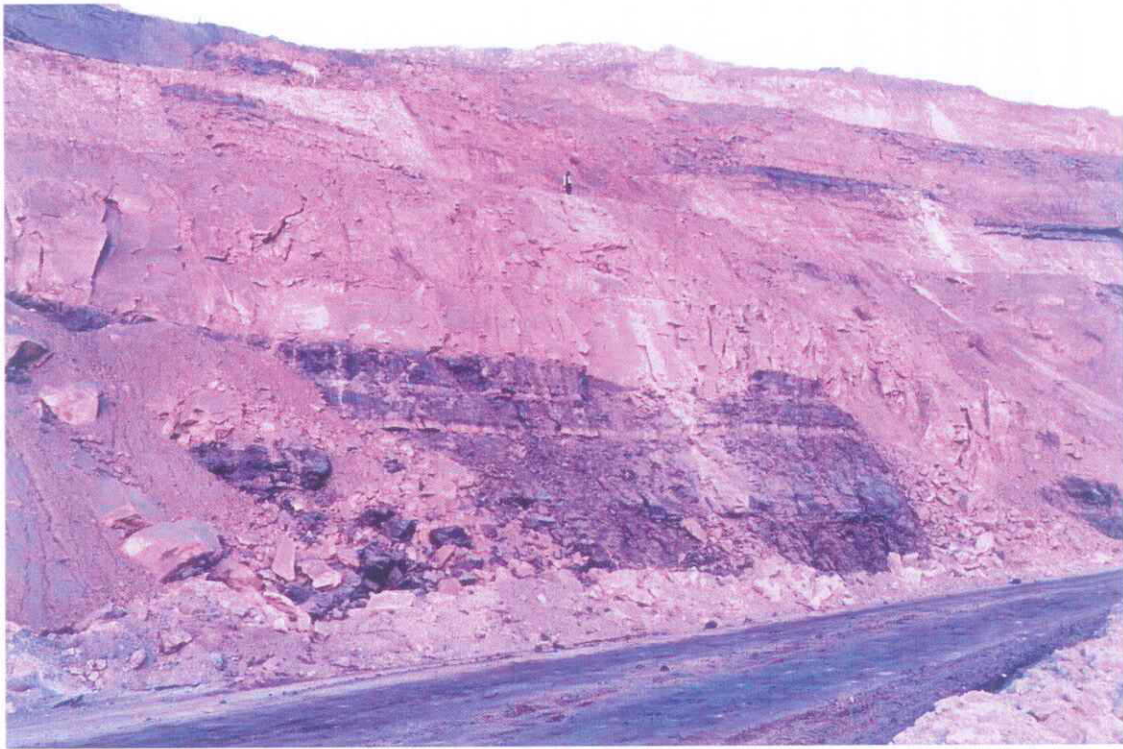
Photograph showing slide, crushing of benches in OB & Coal.

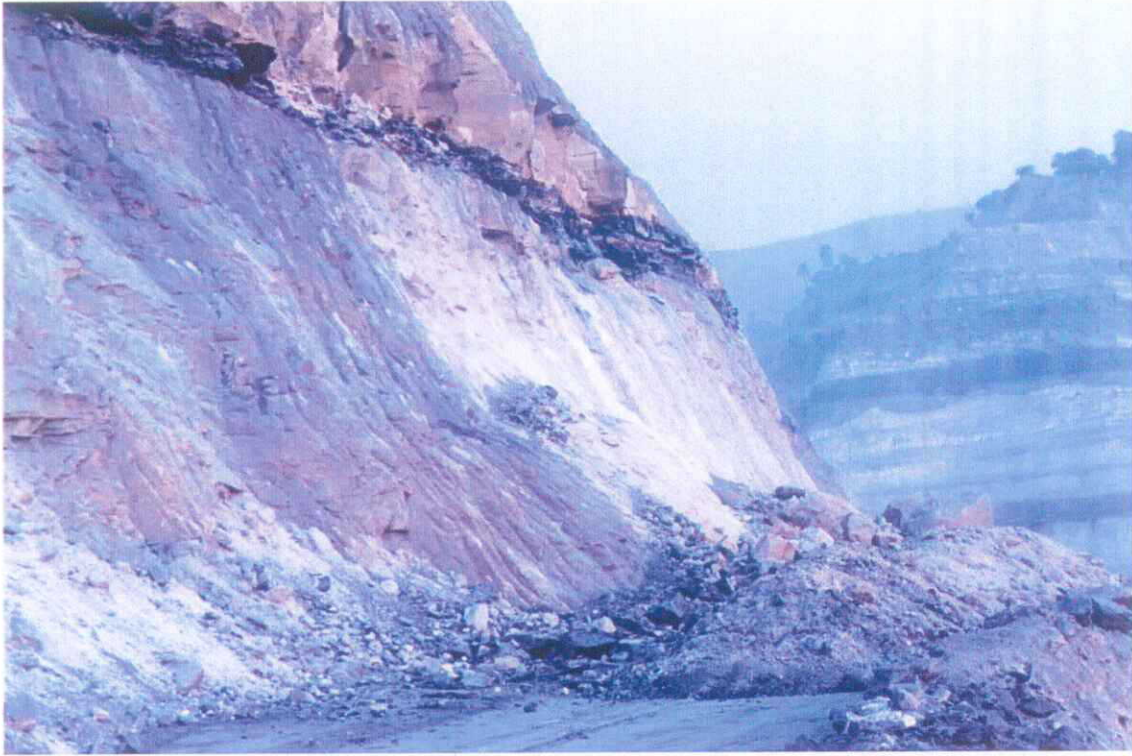
Photograph showing slide, crushing of benches in OB.

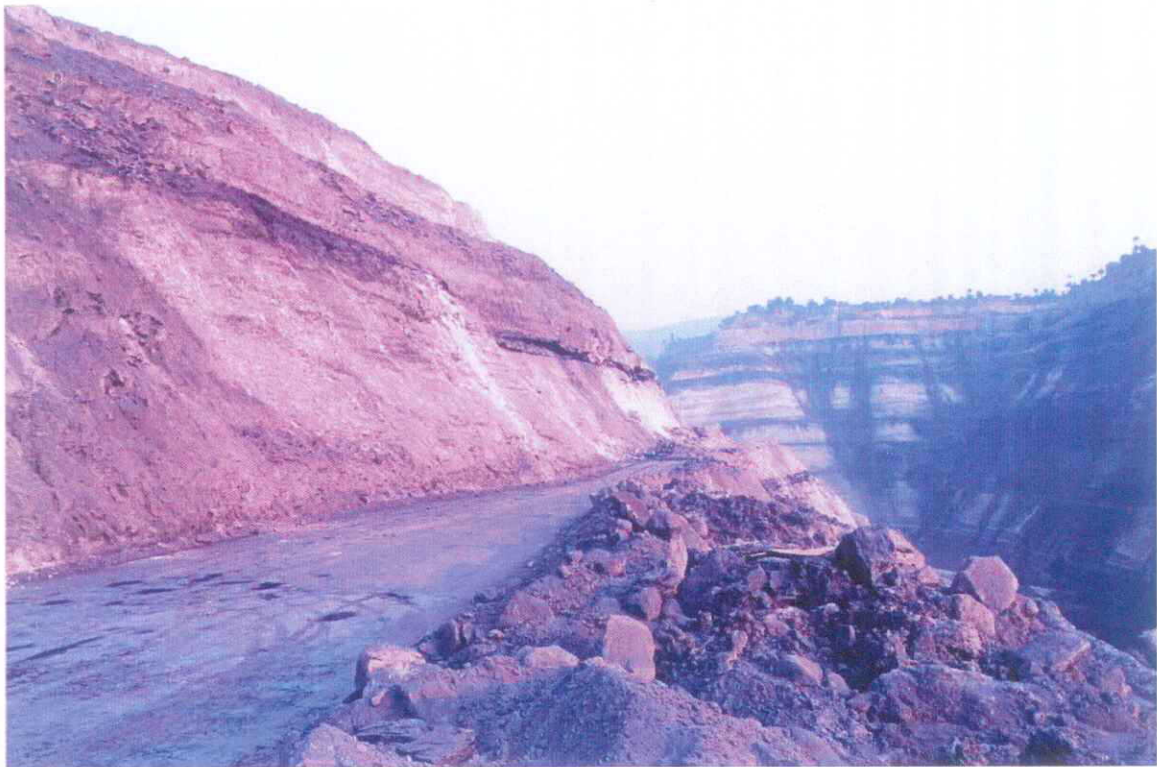
Photograph showing slide.

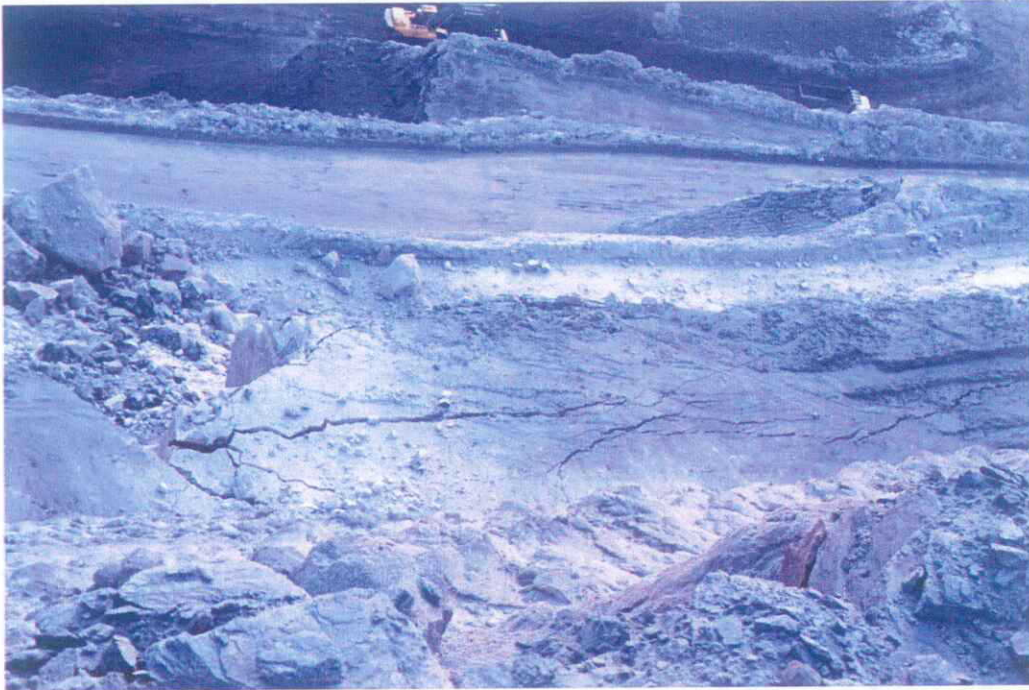
Photograph showing cracks in OB dump.

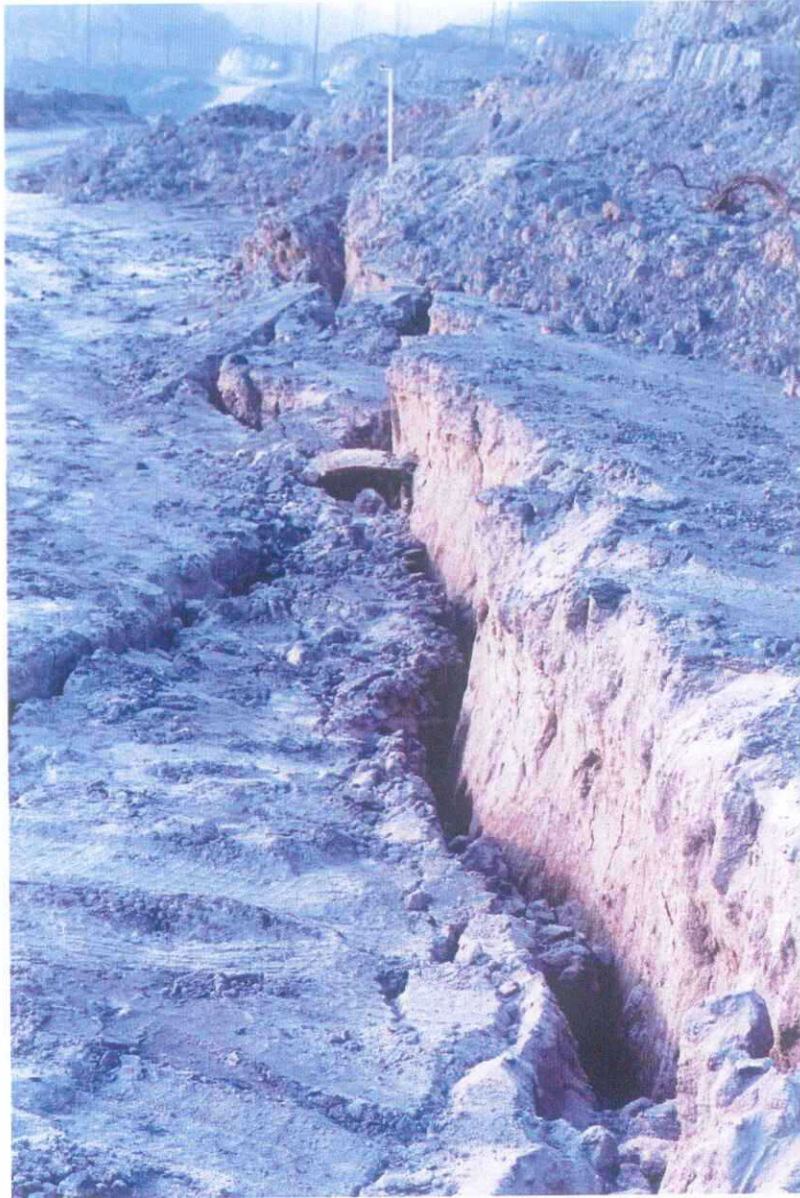
Photograph showing prominent crack & subsiding of OB.

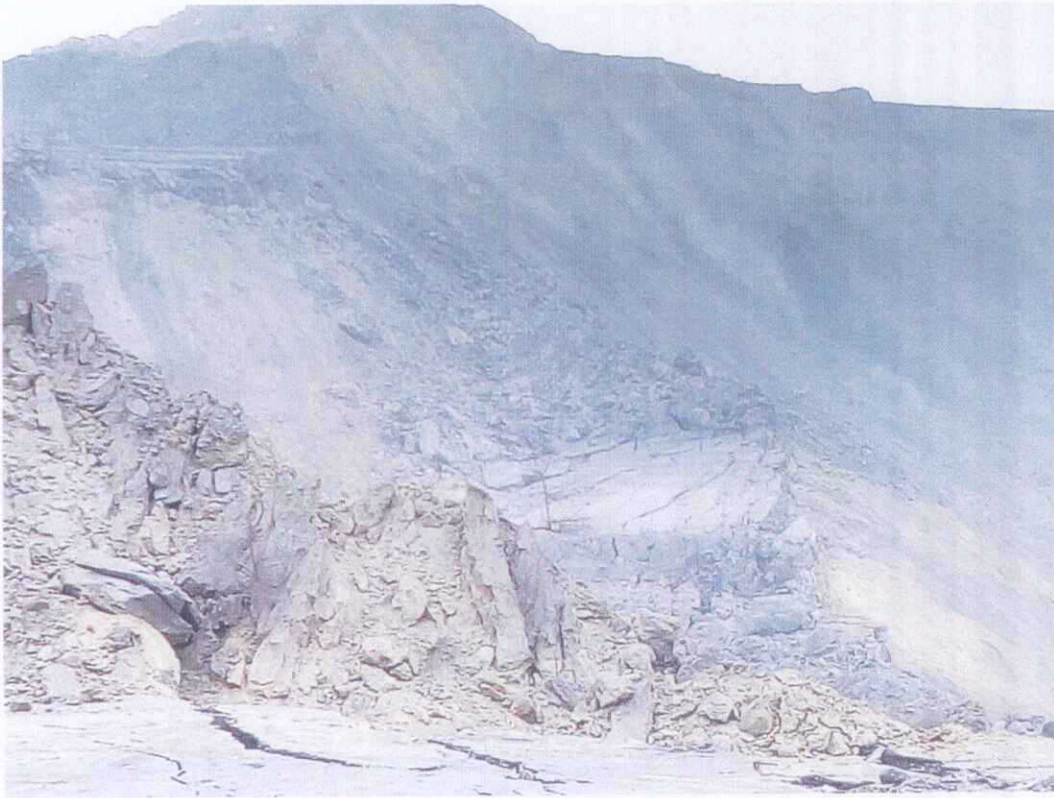
Photograph showing profile of dump slide.

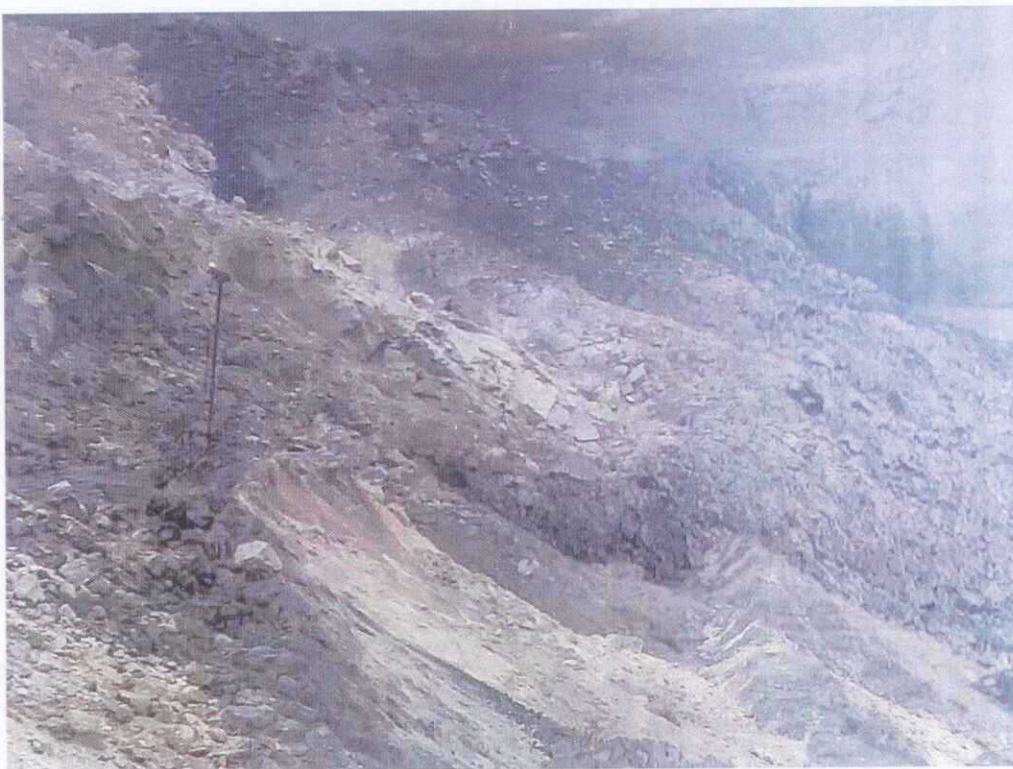
Photograph showing profile of dump slide.

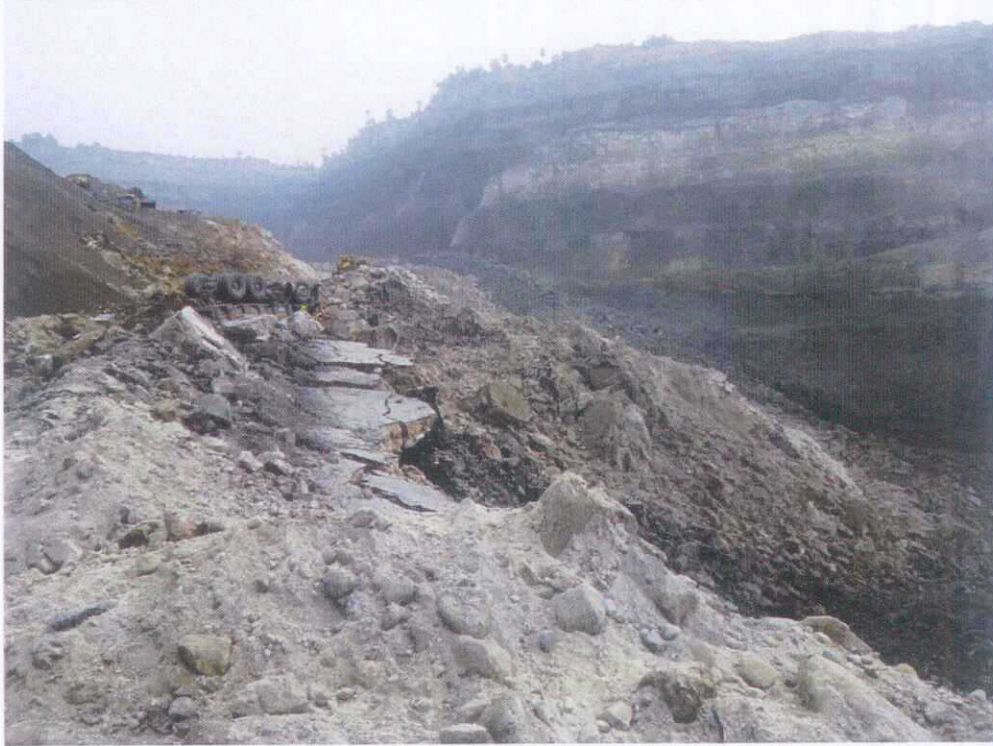
Photograph showing slided mass at the query bottom.

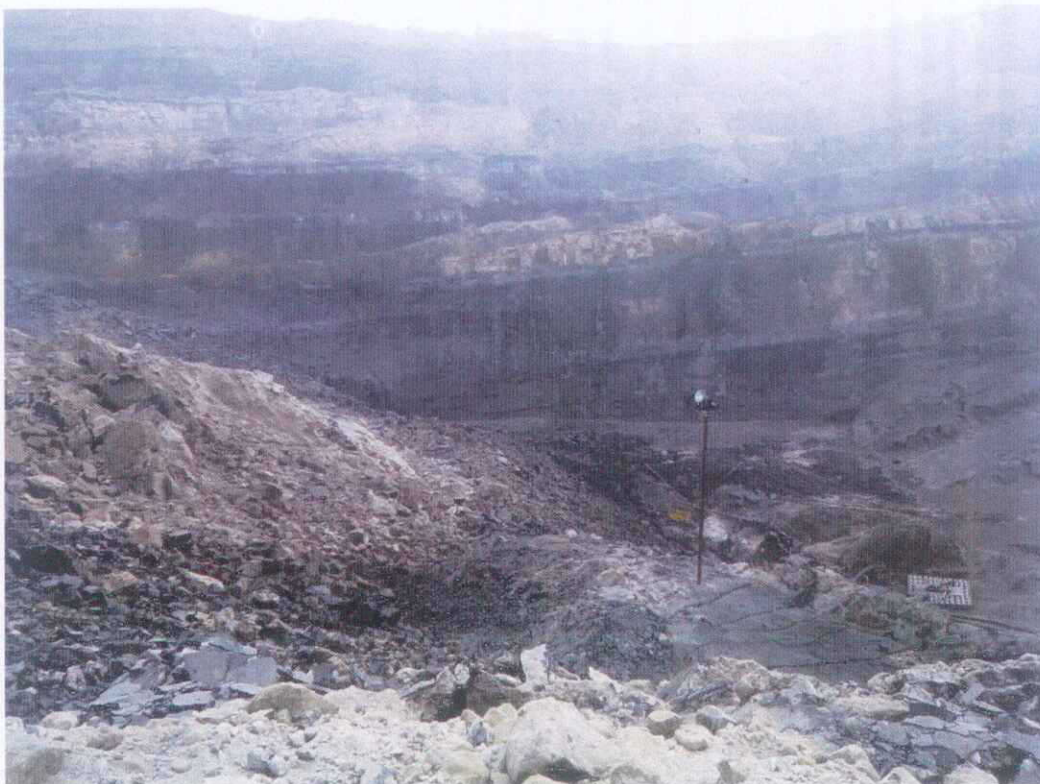
Photograph showing slided mass at the query bottom.

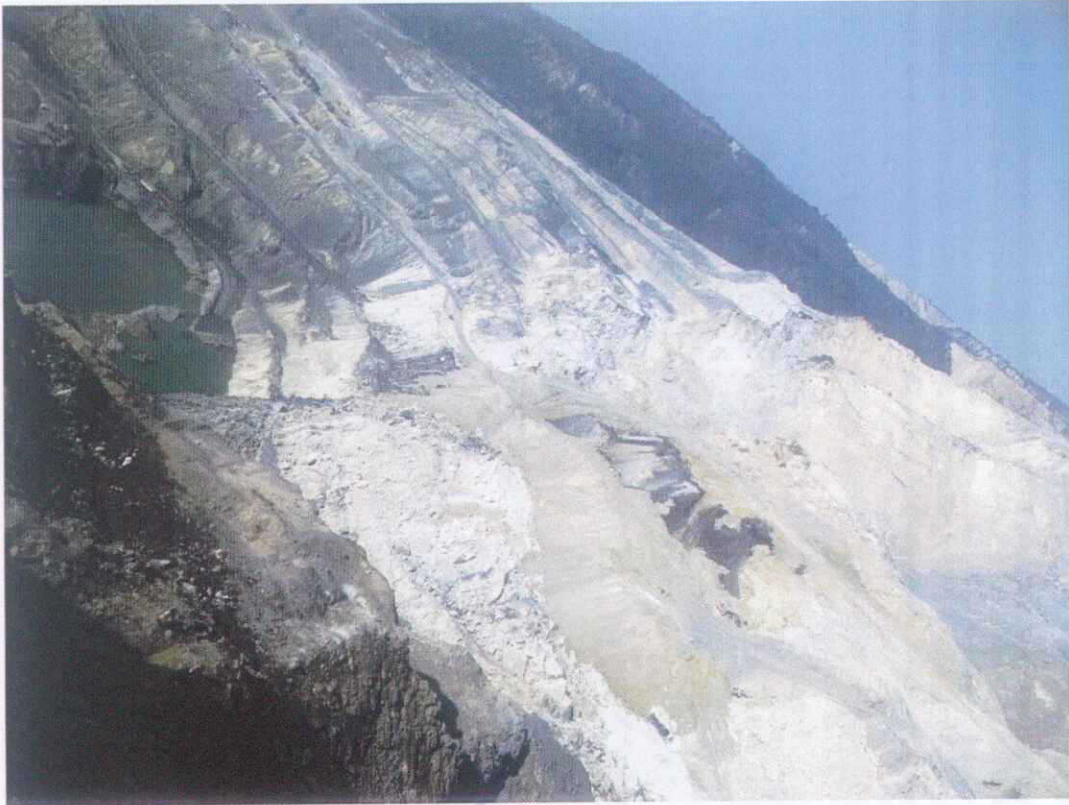
Photograph showing profile of dump slide.

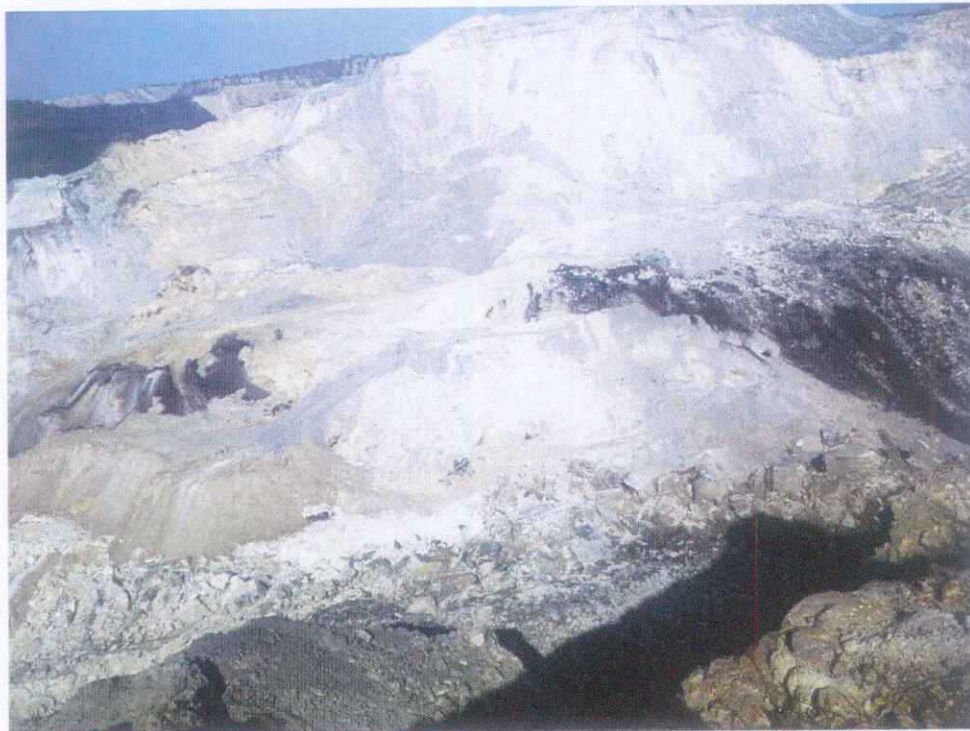
Photograph showing profile of dump slide.

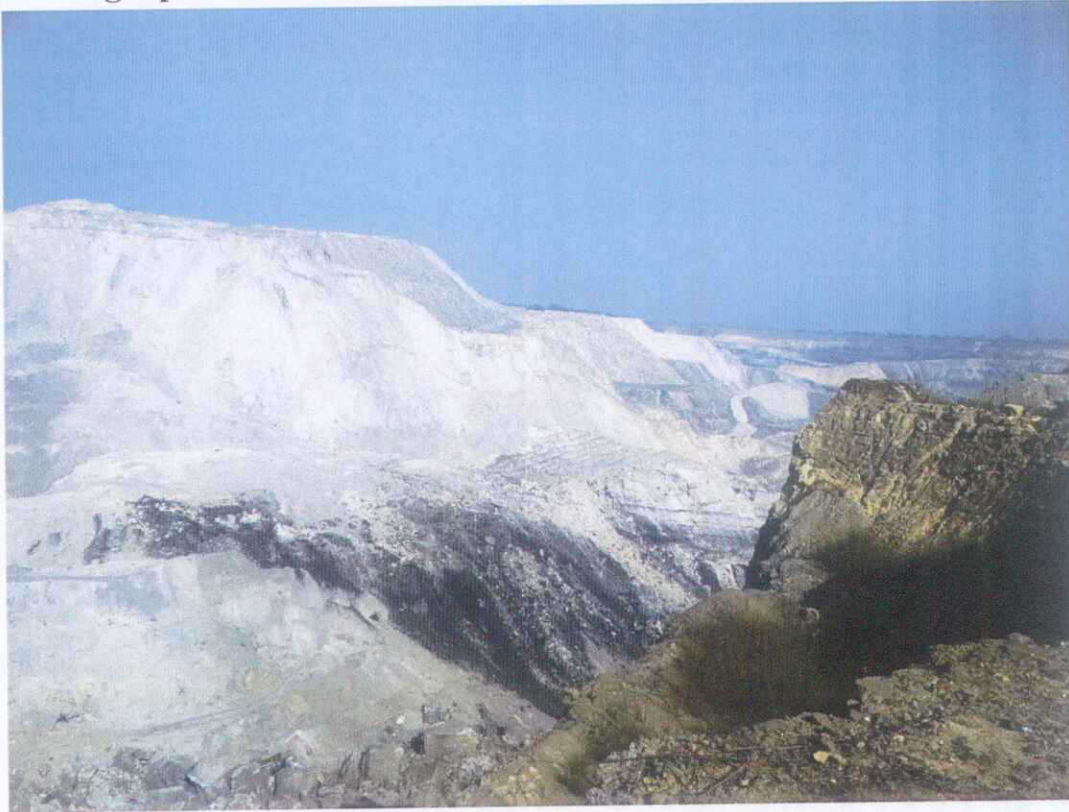
Photograph showing profile of dump slide.

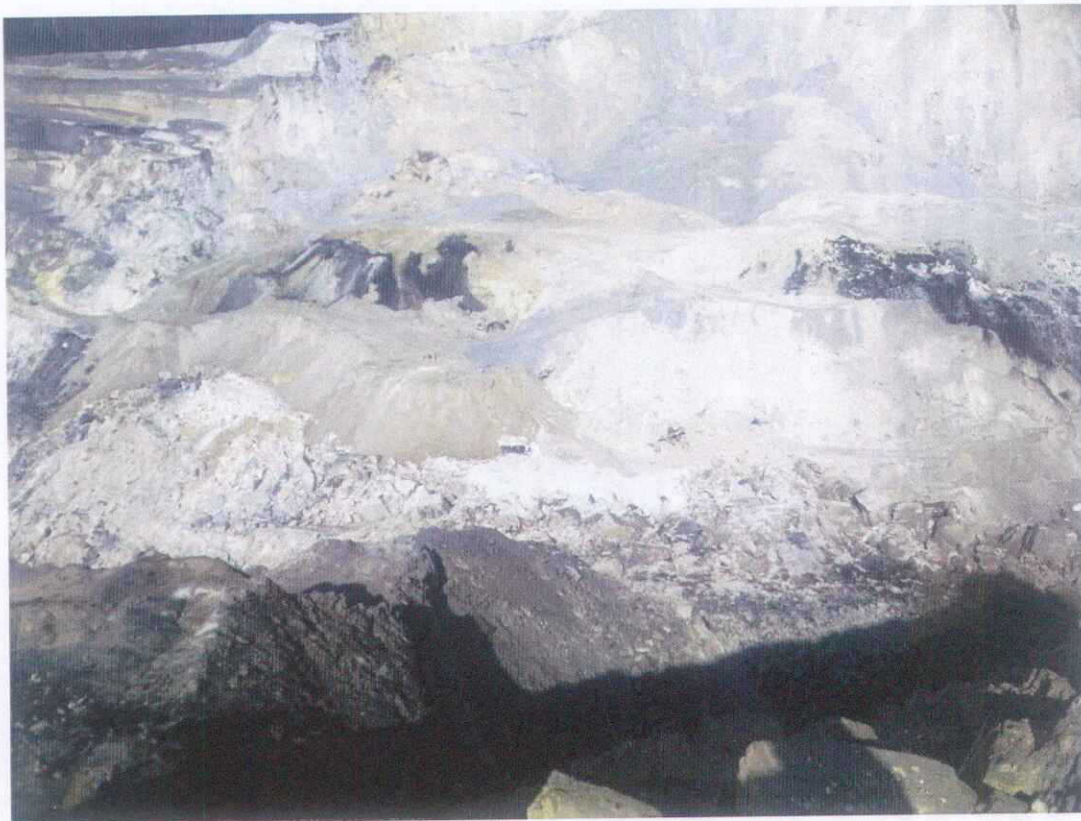
Photograph showing profile of dump slide.

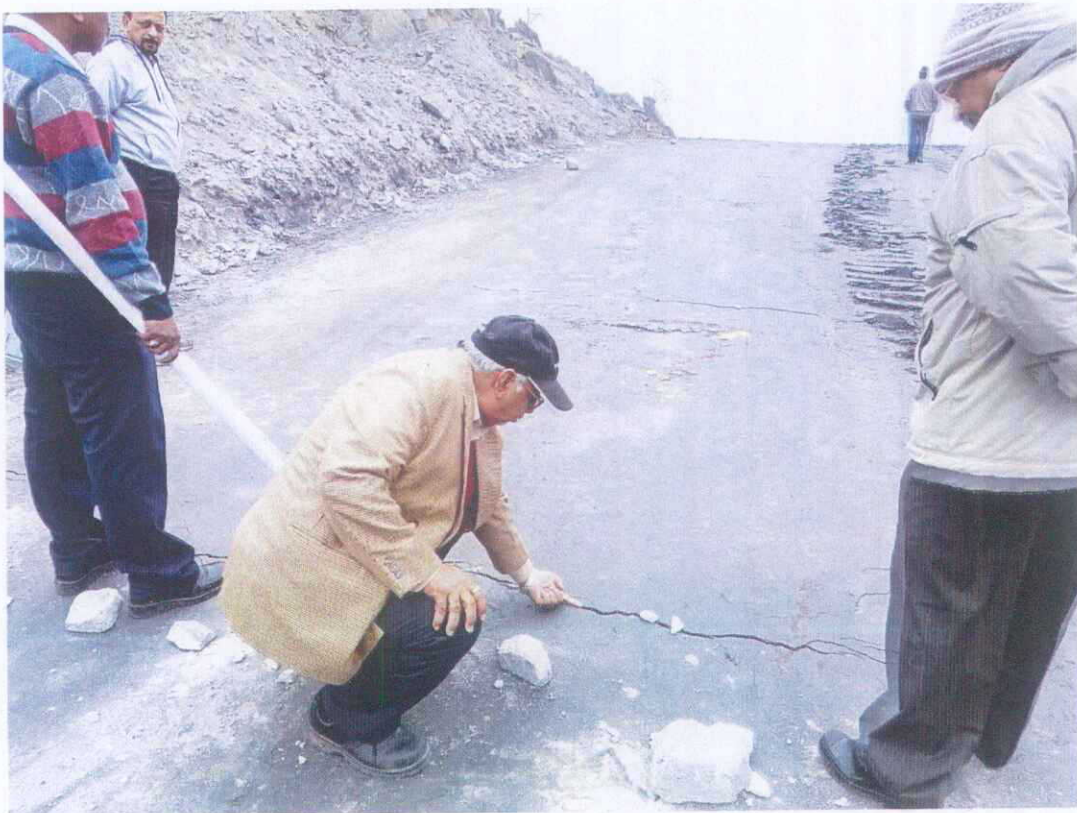
Photograph of enquiry committee inspection at crack of OB dump.

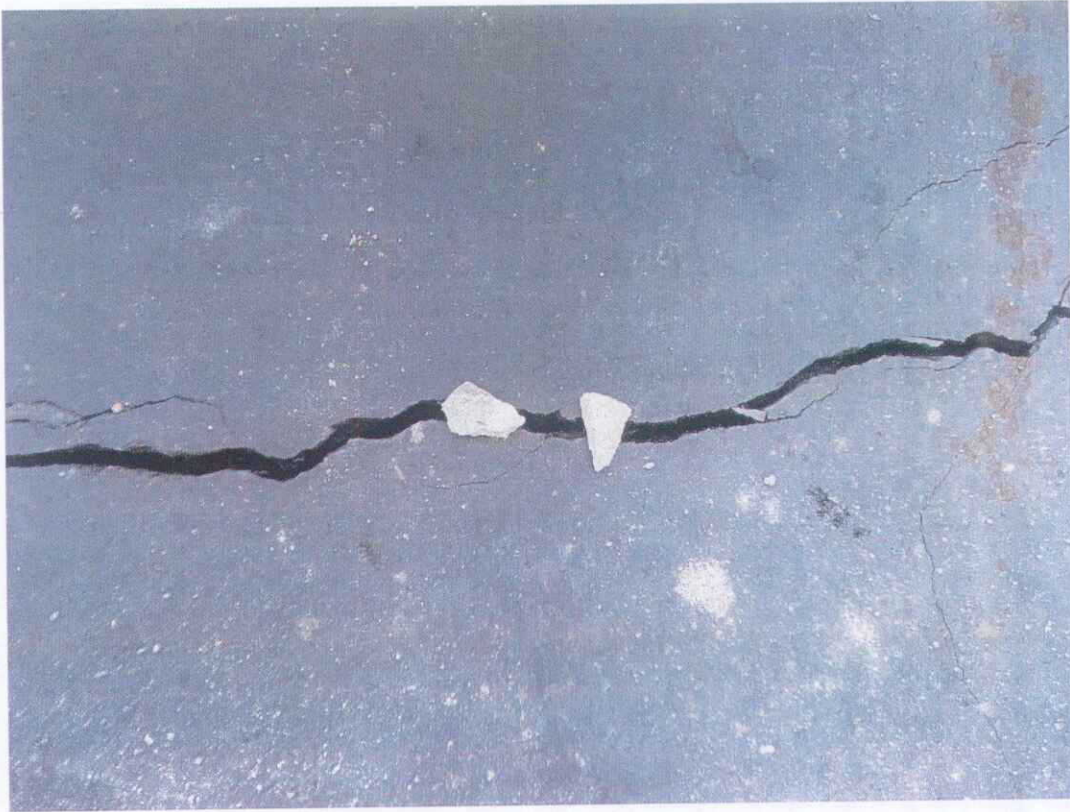
Photograph of crack in OB dump haul road.

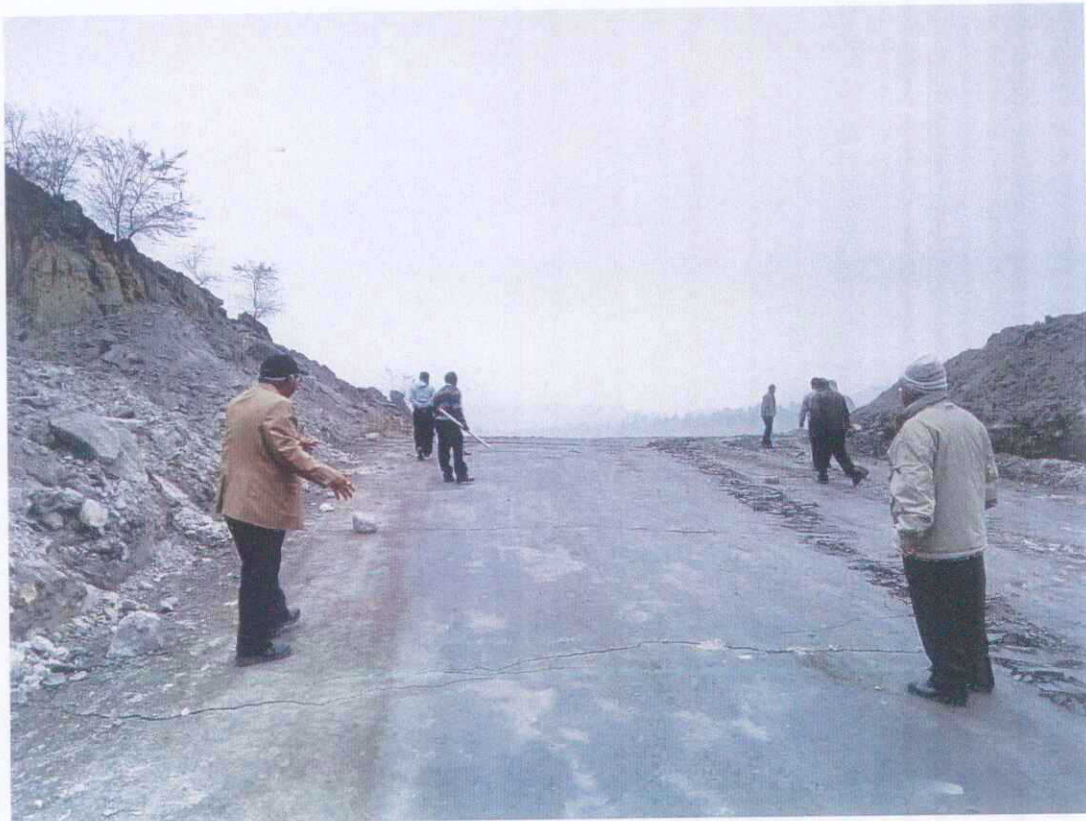
Photograph of enquiry committee inspection at crack of OB dump.

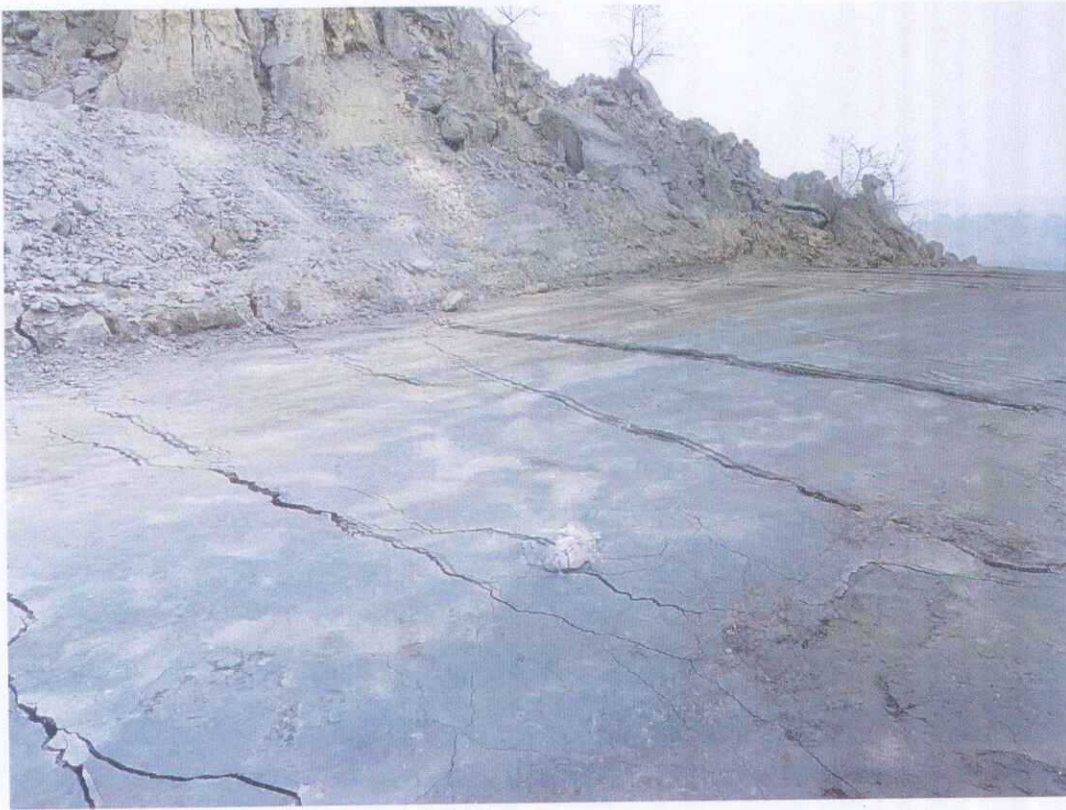
Photograph of crack in OB dump haul road.
