SAFETY ALERT: 37

Dhanbad, dated 20.02.2026

SUBJECT: Fatal accident occurred due to (cause) **FALL OF SIDES** at Satya Krishna Granite Mine (Opencast Mine) of M/s Satya Krishna Granites.

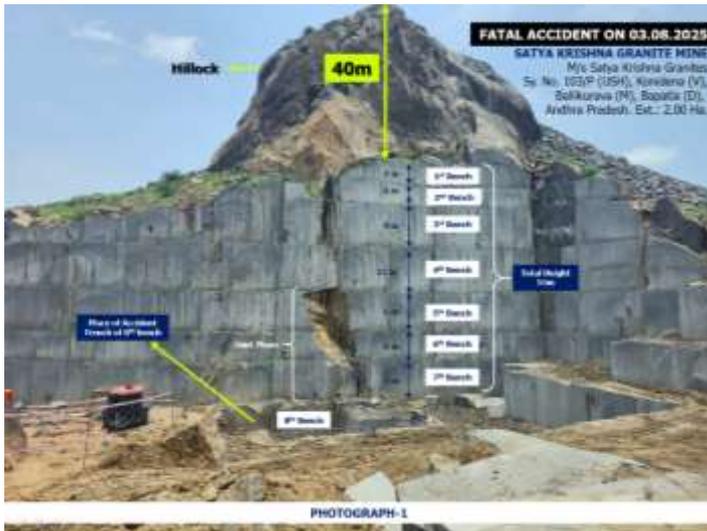
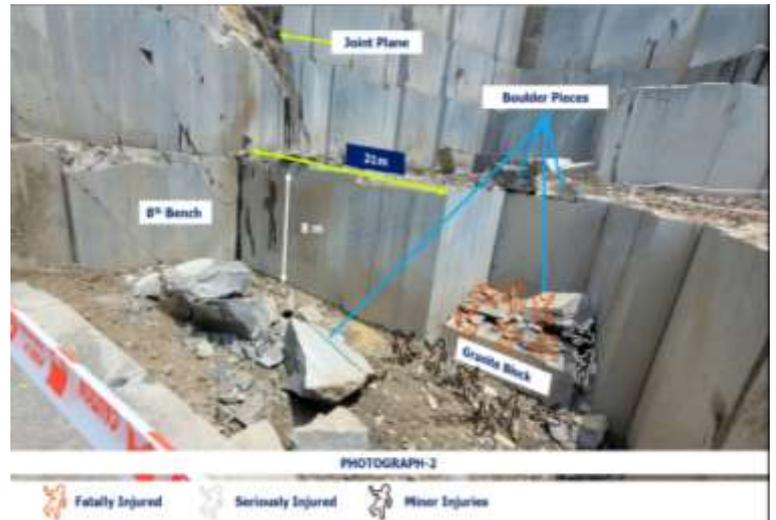
9. Sketch showing the accident :

- Brief Cause : While a group of 14 persons were engaged for drilling & chiseling a granite block on the floor of a lowermost bench of 8 m height at a distance of about 21 m on the western side from the toe of overlying 55 m high bench in an opencast granite mine, a block of granite from the side of high bench with the average size of 14 m x 4.5 m x 0.87 m (about 55m³) got separated from a height of about 23 m & fell on the floor of the bench and broken into pieces; further these pieces fell over the persons working at the lowermost bench, inflicting fatal injuries to six persons and serious bodily injuries to two persons while others escaped with minor injuries.

1. Maintain permissible bench height, width and overall slope angle to prevent side fall.
2. Carry out periodic geotechnical assessment of high benches, especially benches exceeding safe heights.

3. Avoid formation of very high composite benches, stable benches wherever feasible.
4. Ensure thorough scaling of loose, overhanging and cracked rock from bench faces before allowing work below.

5. Conduct scaling: After blasting, After heavy rains and After prolonged inactivity
6. Use mechanized scaling equipment; prohibit manual scaling from unsafe positions.

7. Prohibit deployment of manpower at lower benches within the rockfall zone of upper benches.
8. Clearly demarcate and barricade no-entry zones with warning signage.

9. Follow top-down working principle, Do not carry out drilling, chiseling, or block extraction at lower benches when unstable high benches exist above.

10. Ensure that upper bench operations and stabilization are completed before work is taken up below.
