ALERT

| Name of the Mine | Kammaturu Iron Ore Mine |
| Date and time of accident | 13.04.2019 at 17:50 hrs. |

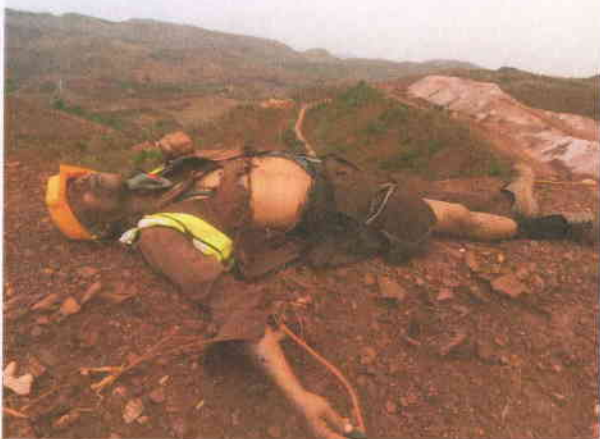
| Deceased person lying on the berm, after lightning struck. | Damaged Shoes. |
| Prima facie cause of the accident | While a mining mate was supervising the movement of dump truck for unloading, at dumping yard, a thunder storm and lightning occurred and he succumbed due to the lightning injuries. |

A LIGHTNING PROTECTION STUDY TO ASSESS THE RISK ASSOCIATED WITH LIGHTNING SHALL BE CONDUCTED IN ALL OPENCAST MINES, FOR PROVIDING SUITABLE LIGHTNING PROTECTION SYSTEM, TO AVOID SUCH ACCIDENTS
