# REPORT of HIGH POWERED COMMITTEE on Accident in the Deep Mining Zone of Rajmahal, OCP, ECL on 29 December 2016

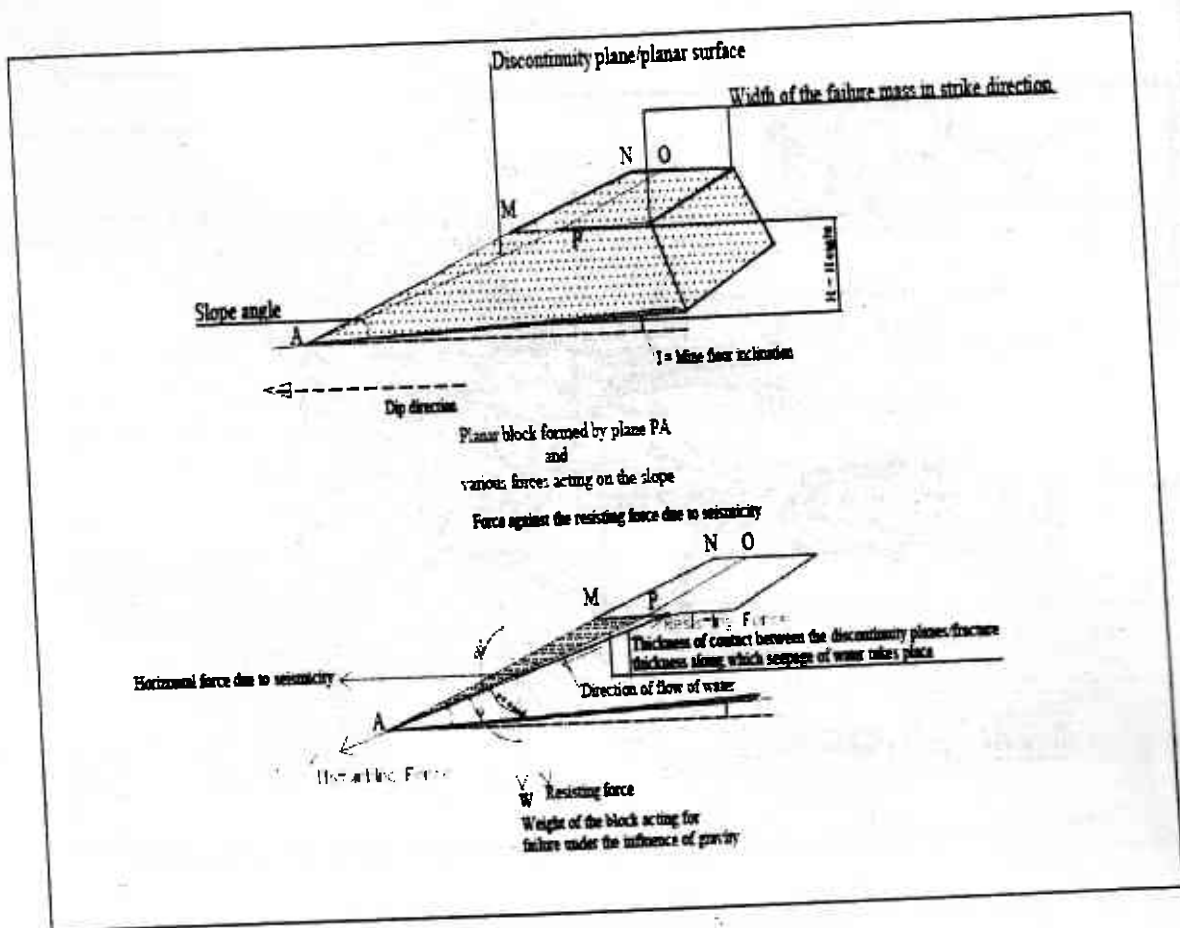
Fig 3 Free body diagram for plane failure analysis

- i) The batter(intersected by unidentified Fault planes near section CC' and DD') in the failed zone seems to have suffered plane failure (Fig 3).
- ii) Unidentified Fault planes might have also led to formation of potential wedge failure block within the failure zone (Fig 4) aggravating the failure condition.

- i) It has been observed that a number of unidentified fault planes / shear zones were existing in the Deep Mining Zone.
- ii) The attitude (i.e. strike direction, dip direction and dip amount) of unidentified fault plane was such that it intersected the batter on the down throw side of fault F8-F8 leading to potential plane failure block. The unidentified fault plane is shown in Fig 2 and the mechanisms of failure is shown in Fig 3.

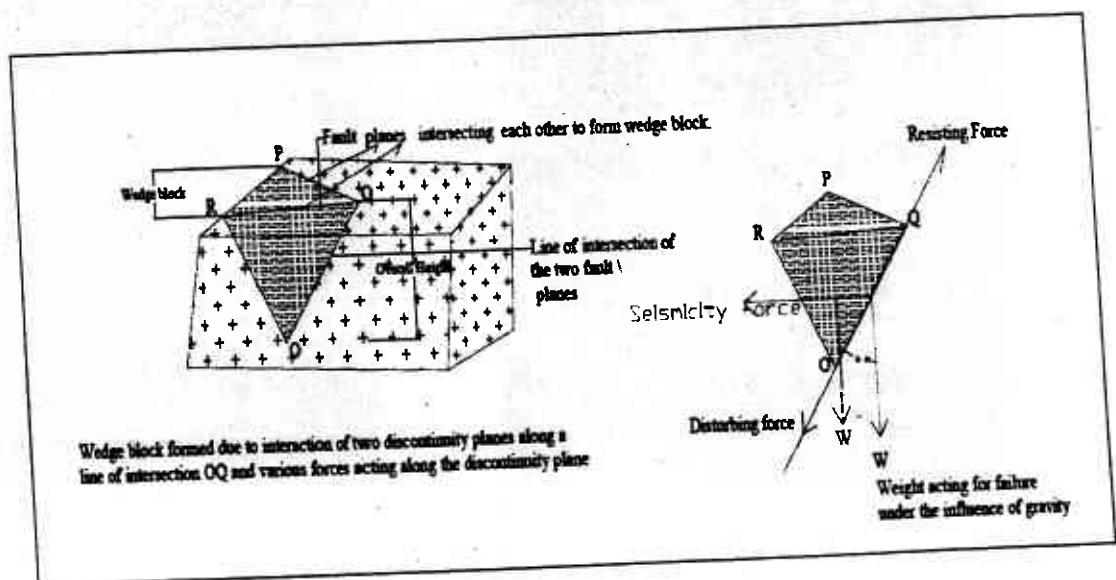
Fig 4 Wedge Failure

- iii) Other than the plane failure, formation of potential dangerous wedge due to presence of other fault planes on both ends of failure block might have added to the instability of the batter. This failure mechanism is explained in Fig 4.
