INSPECTION REPORTS OF
OFFICIALS OF DGMS OF
INSPECTIONS MADE BETWEEN
JANUARY, 2011 AND DECEMBER, 2016

Name of the Mine	Rajmahal OCP
Name of the Owner	M/s. E.C.Ltd
Name of the Agent	Shri M.K.Rao, FCC
Name of the Manager	Shri K.Kishore, FCC
Name of the I.O.	Sri S. Chandramouli, DDMS
Date of Inspection	22.02.2011 & 23.02.2011

Subject: Part Inspection-Rajmahal OCP

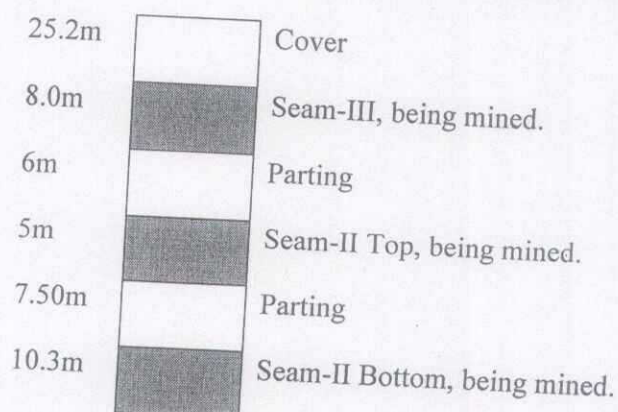
6.0 Section as revealed by bore hole No.RJH-21 is given below:

- 1.0 **Introduction:** I paid a visit to the mine on 22.2.11 afternoon & on 23.2.11 forenoon to inspect the measures taken to prevent accident in view of the mine classified as Accident Prone Mine.
- 2.0 A Section of strata through bore hole No.RJH-21 shown as below

surface		
25.2m		Cover
8.0m		Seam-III, being mined.
6m		Parting
5m		Seam-II Top being mined
7.50m		Parting
10.3m		Seam-II Bottom being mined
