WARNING

Name of the Mine	Palukuladoddi Road Metal and Building Stone Mine (Survey No. 453 of Palukuladoddi Village, Dist: Kurnool) (Mine is not on record of DGMS)	
Owner of the Mine	Shri A. Ramkrishnudu	
Date & Time of Accident	20.07.2018 at about 08:00hrs	
Number of Persons Killed	Two (02)	
Number of Persons Seriously Injured	Three (03)	
Photographs

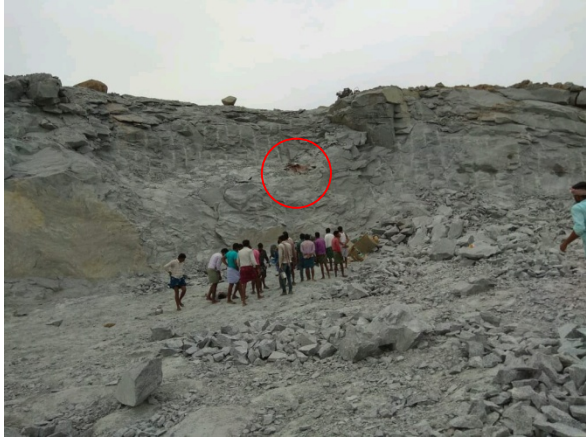
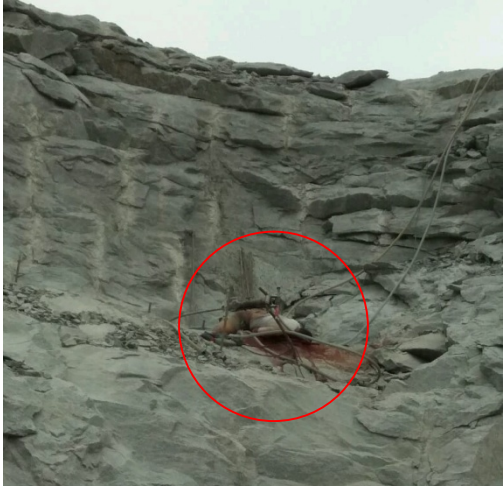
Prime Facie Cause of the Accident	While four drillers were engaged in drilling of 32mm diameter holes with jack hammer pneumatic drilling machines along face of bench in an opencast road metal quarry, a tractor driver reversed compressor mounted tractor along edge of bench in an attempt to adjust length of compressed air hose, it got uncontrolled and fell down about 2.5m to 3.0m over the drillers causing multiple bodily injuries to tractor driver & crush injuries to one of driller to which both of them died almost instantaneously and serious bodily injuries to three other drillers.
