SAFETY ALERT: 19

SUBJECT: Fatal accident occurred due to **Electrocution** at **Gevra Opencast Mine** of M/s SECL.

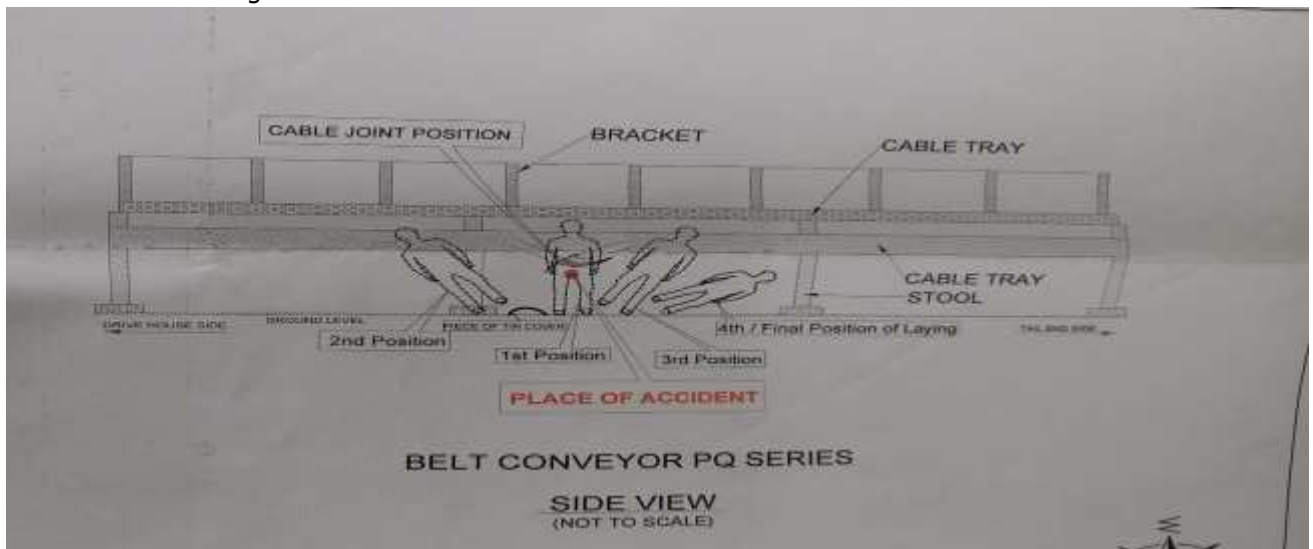
1. Name of Mine : Gevra Opencast Mine
2. Name of Owner : M/s S.E.C.L.
District : Korba
State : Chhattisgarh
3. Mineral : Coal
4. Date and time of accident : 18.06.2025
5. Place of accident : Along P-1 Conveyor Belt of P-Q Circuit of Coal Handling Plant
6. Killed : 1 Name: Shri Heera Lal, Designation: Helper (Elect), Age: 38 Years
Experience: 3 years
7. Seriously Injured : Nil
8. Brief Cause : Shri Heeralal S/o Shri Khamhan Singh was engaged in maintenance work (Cable joint checking) in PQ Circuit of Coal Handling plant. He received an electric shock and fell down on the ground, later succumbed on the way to hospital."
9. Sketch showing the accident:

10. Best Practices
 1. *Temporary Cable Joints shall be avoided, cable jointing shall be done with standard cable joint kit by maintaining the earth continuity through armour.*
 2. *The Supervisor should ensures portion of the installation where work is to be carried out is rendered dead and safe for working by taking shutdown along with Lock out Tag out, absence of supply shall be ensured with Non-contact Line detector and discharging of residual charge by earthing.*
 3. *Regular inspection of the Supervisor for identification and rectification of such unsafe conditions.*
 4. *At least one person trained in first aid shall always be present on site during any electrical maintenance work.*
