SAFETY ALERT: 20

dated 22.08.2025

SUBJECT: Fatal accident occurred due to (cause) Fall of Dumper at (location) 4th Granite bench of OC mine.

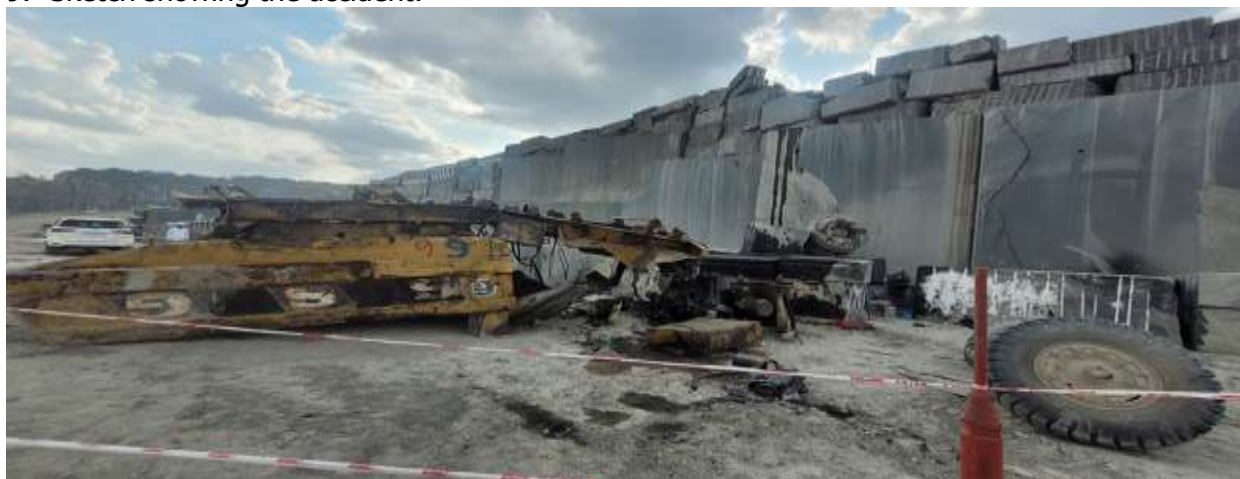
9. Sketch showing the accident:

2) Name: Shri Suresh Raita, S/o. Minaketan Raito, Designation: Cutter, Age: 46, Experience: 7 months
8. Brief Cause : While a dumper was moving downwards with four workmen including dumper operator, on a steep gradient haul road, suddenly dumper got uncontrolled and fell from 3rd bench to immediate 4th bench inflicting fatal injuries to two workmen and seriously bodily injuries to other two workmen

10. Best Practices: 1) Haul road should not have a gradient more than 1 in 16. Ensure that haul roads are designed with proper gradients, widths, and turning radii that are appropriate for the equipment being used.
2) Persons shall not ride on a dumper and on the board of a running dumper. Where possible, create benches or steps along the haul road to provide a better slope and minimize the risk of vehicles overturning.
3) When a road existing above level of surrounding area, a strong parapet wall/berm of adequate dimensions shall be provided.
