SAFETY ALERT: 38

SUBJECT: Fatal accident occurred during chute cleaning at Joda East Iron Mine of M/s. TATA Steel Limited.

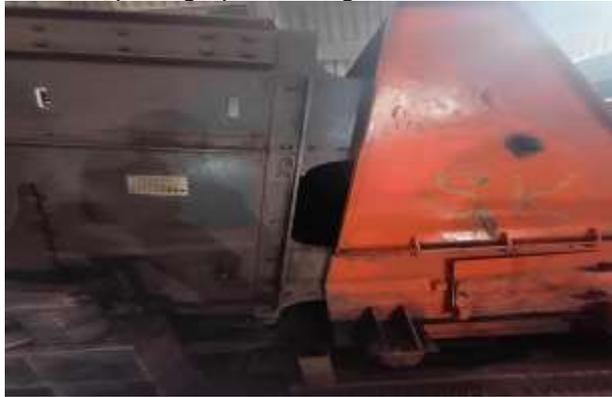
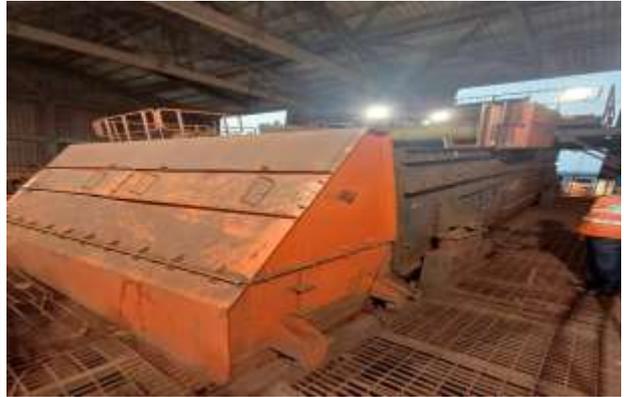
1. Name of Mine : Joda East Iron Mine
2. Name of Owner : M/s. TATA Steel Limited
District : Keonjhar
State : Odisha
3. Mineral : Iron Ore
4. Date and time : 04.08.2025; 11:55 PM
of accident
5. Place of : Secondary Screen area, 3MPTA Plant
accident
6. Killed : Name: Suraj Mahto
Designation: Mechanical Helper (contractual)
Age: 27 Yrs
Experience: 08 months.
7. Seriously Injured : NIL
8. Brief Cause : "While a contractual mechanical helper was engaged for cleaning of a jammed chute by entering into the area between the screen and chute cover, the disturbed chute cover (hood) suddenly retracted to its original position, causing his head to trap between the screen and cover, to which he succumbed on the spot."
9. Sketch/photograph showing the accident:

10. Best Practices: Isolation of Energy Sources (Lockout-Tag out-Try-out)
 - Ensure total isolation of all energy sources (electrical, mechanical, hydraulic, pneumatic, and gravitational) before clearing jams.
 - Implement Lockout-Tag out-Try-out procedures and permit systems.
 - Provide physical locking arrangements on chute covers, hoods, and moving parts.Prohibition of Entry into Hazard Zones
 - Strictly prohibit entry between moving or spring-loaded components such as screens, chutes, and covers.
 - Redesign chutes to allow cleaning from outside using long tools, air lances, or water jets.
 - Provide remote or mechanized chute cleaning systems wherever feasible.

- Fit positive locking devices or pins to chute covers/hoods to prevent unintended movement.
- Replace spring-loaded or gravity-operated covers with mechanically secured designs.
- Install interlocks so that access doors or covers cannot be opened unless the system is fully isolated.

- Ensure direct supervision by a competent supervisory official during jam clearing.
- Engage only trained and authorized persons for chute cleaning.
