SAFETY ALERT: 40

SUBJECT: Fatal accident occurred due to (cause) **DUE TO RUN OVER BY TRUCK** at Andhra Pradesh Granite (Midwest) Mine (Opencast Mine) of M/s Andhra Pradesh Granite (Midwest) Private Limited.

1. Name of Mine : **ANDHRA PRADESH GRANITE (MIDWEST) MINE**
2. Name of Owner : M/s Andhra Pradesh Granite (Midwest) Private Limited
District : Prakasam
State : Andhra Pradesh
3. Mineral : Granite
4. Date and time of accident : 11.11.2025 & 08:25Hrs
5. Place of accident : Haul Roads
6. Killed :

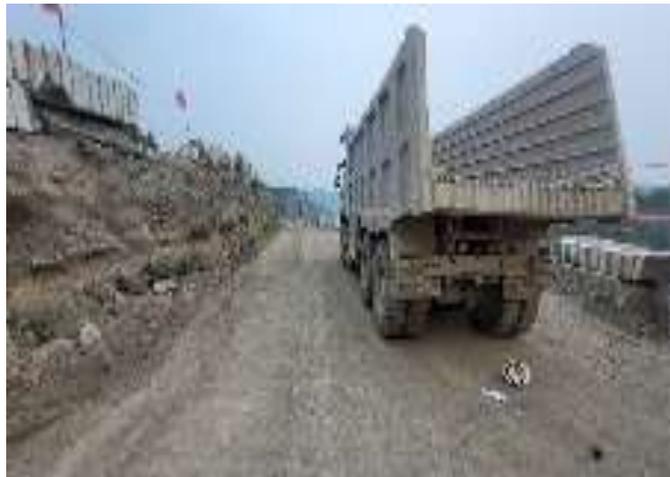
7. Seriously Injured : Nil
8. Brief Cause : A truck moving in the forward direction ran over Shri Sambi Reddy, Supervisor, who was walking along the haul road.
9. Sketch showing the accident :

10. Best Practices : **Segregation of Pedestrian and Vehicle Movement**
 - Provide dedicated pedestrian walkways physically separated from haul roads.
 - Restrict pedestrian movement on haul roads to absolute minimum and only when unavoidable.**Haul Road Design and Maintenance**
 - Ensure haul roads are of adequate width, well maintained, and free from potholes.

- Enforce strict speed limits on haul roads.
- Use speed governors, GPS tracking, and speed monitoring systems.
- Install speed breakers/rumble strips at pedestrian crossing zones and near work areas.

- Ensure adequate illumination on haul roads, especially during night shifts.
- Provide high-visibility reflective PPE (jackets, helmets) to all supervisors and workers.
- Fit vehicles with functional headlights, tail lamps, reverse alarms, and flashing beacons
